**A SEMI-ANNUAL AQUATIC MONITORING REPORT FOR  
AQUATIC SAMPLE SITE BFRK-3 LOCATED NEAR ROARING  
FORK IN WISE COUNTY, VIRGINIA**

**Prepared for:  
Red River Coal Company, Inc**

**ATS PROJECT NO. 1199.01**

**September 2014**

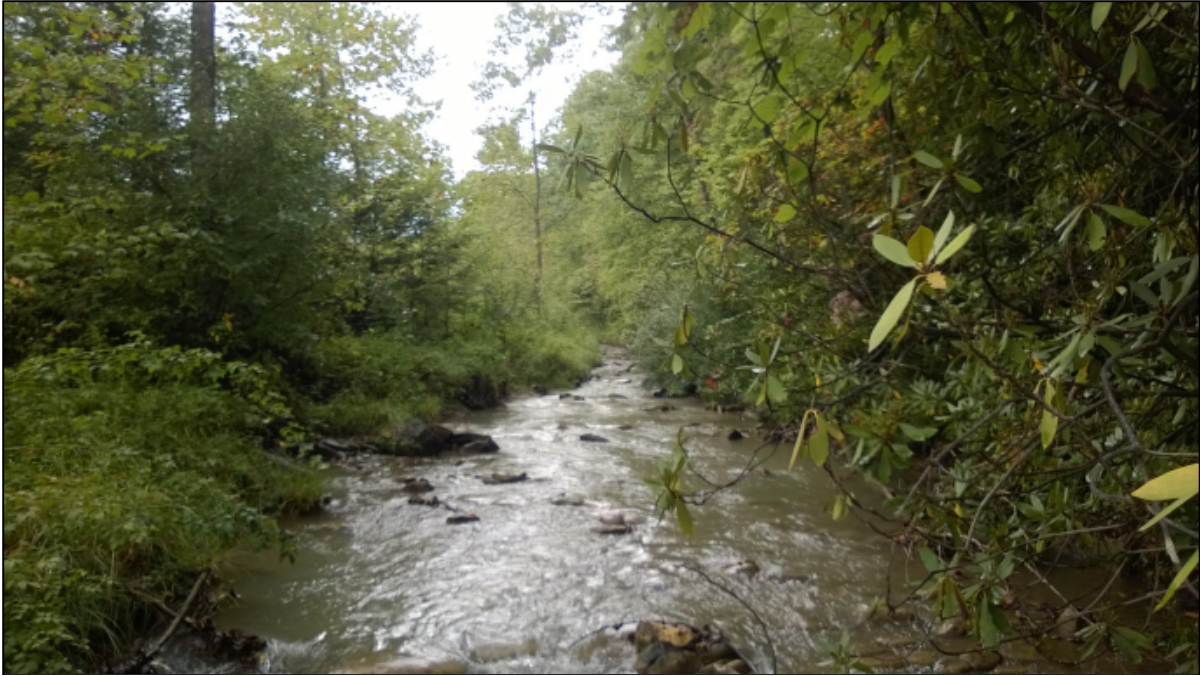
**Figure 10: BRFK-3 upstream view**

The stream habitat at BRFK-3 scored 135 of 200 (Appendix A), indicating the habitat is partially supporting its designated use. The stream was approximately 20 feet wide and characterized mostly by a series of riffles and runs (Figures 8 and 9). Flow occupied >75% of the stream channel. Embeddedness was suboptimal with 25 to 50% of the substrate particles surrounded by fine sediment. The water was clear but there was slight to moderate deposition of sediment within the streambed. The stream banks were moderately stable but the right bank had a narrow riparian zone.
